MYSTERIES OF TEMPERATURE MEASUREMENT OF THE CLAUS FURNACE

Laurance Reid Gas Conditioning Conference February 22-25, 2015 – Norman, Oklahoma USA

ABSTRACT

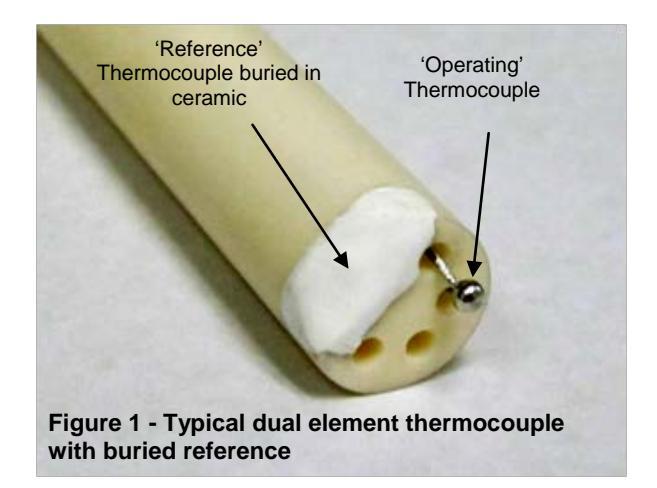
Thermocouples designed for Claus service are normally equipped with two separate thermocouple junctions, each providing its own independent output signal. These two elements are mounted in the same location adjacent to each other, but one of the two, the "reference" element, is embedded in solid ceramic in such a way that if the ceramic thermowell becomes broken, reaction gases do not readily come in contact with it, preventing immediate corrosive attack. (See Figure 1) The "operating" element, on the other hand, under the same breakage condition, is

directly exposed to reaction gases and corrosion immediately ensues, causing a deterioration of the output signal. Therefore, if the "operating" element signal is declining relative to the protected "reference" element's signal, it may be assumed that the thermowell has become broken. If the two separate thermocouple elements in a given thermocouple are reading within approx 20°C of each other, it may be assumed that they are reading accurately.

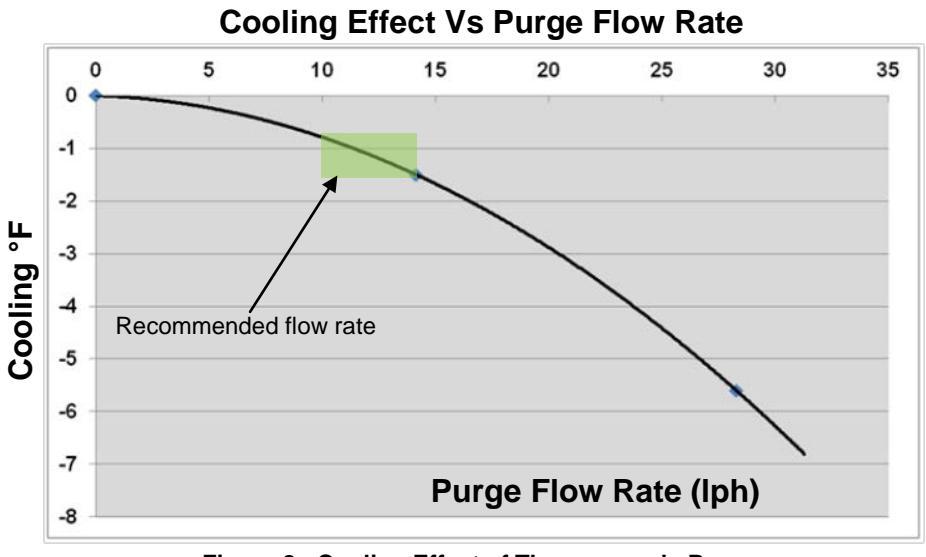
Figure 2 - Cooling Effect of Thermocouple Purge

Thermocouples used in Claus service must be continuously purged to provide long term reliability and accuracy. But, the thermocouple can read low if this purge is significantly higher than the recommended purge rate (approx 11 liters/hour). This low recommended flow rate cools the thermocouple by only a few degrees, but cooling rapidly increases as the purge rate is increased. Excess purge cooling can easily be tested by temporarily turning off the purge flow

and observing a rise in the indicated temperature. (Briefly turning off the purge will not harm the thermocouple.)

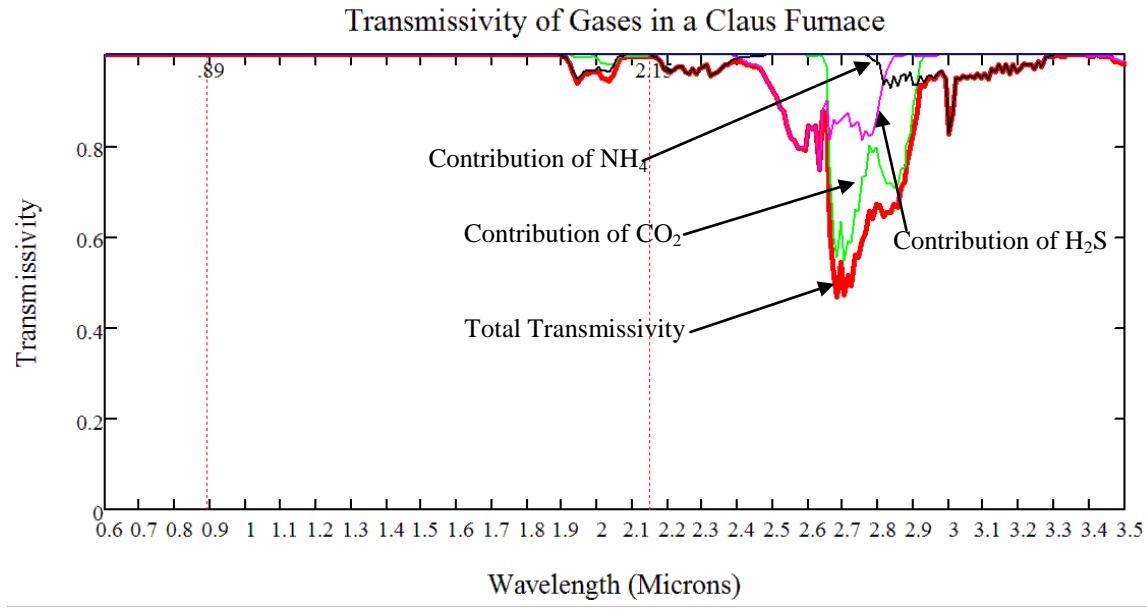
Figure 3 Transmissivity of gases near the burner

For pyrometers intended to measure gas temperature or partial gas temperature (where the measurement is a combination of gas and refractory temperature), the measurement can be affected by changes in the gas composition. Figure 3 shows the transmissivity of a mixture of gases near the burner of a claus furnace. Here the feed gas is largely un-reacted. The atmosphere is mostly transparent over much of the near and mid-infrared wavelengths, except for the region around 2.7 microns, where the atmosphere transmits only about half of the light passing through it. A pyrometer operating at 2.7 microns would read about halfway between the gas temperature and the hot-face temperature.

Figure 5 shows the transmissivity of the same gases near the tube sheet. The composition has changed considerably during the course of the reaction along with a change in transmissivity. Figures 3, 4, and 5 are for a constant feed gas composition. Changes in feed gas composition and flow rate will further affect the transmissivity. While it is possible to compensate for the transmissivity for a given set of operating conditions, the accuracy will suffer as soon as the operating conditions change. Because of the changes in gas transmissivity, attempts to measure gas temperature with a pyrometer are not recommended.

Note that at around 2.1microns, the atmosphere is completely transparent under all normal operating conditions. A pyrometer operating at that wavelength will accurately read the refractory temperature regardless of gas composition.

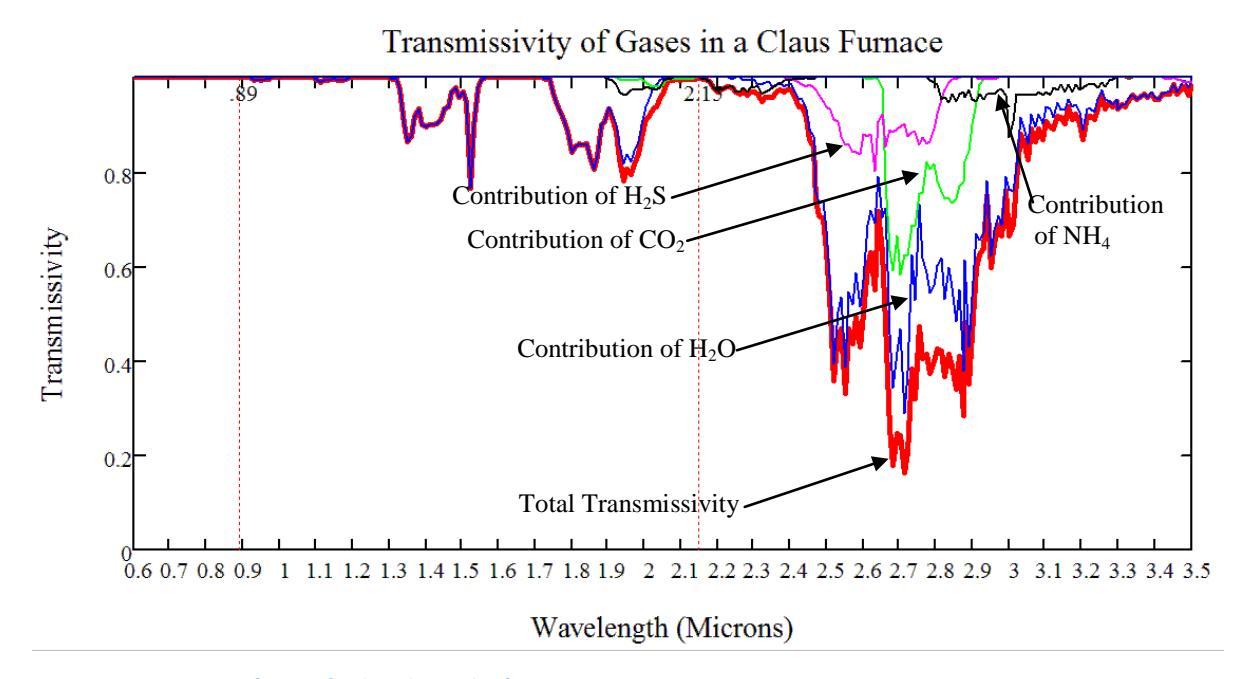
Figure 4 Transmissivity of gases further down the furnace

Figure 4 shows the transmissivity of the same gases further down the furnace. Here, the reaction is about 25% complete. The transmissivity is dominated by water vapor that has been created by the reaction. A pyrometer operating at 2.7 microns would now be reading closer to the gas temperature, but still be affected by the refractory temperature behind it with about a 80%/20% weighting between the two temperatures.

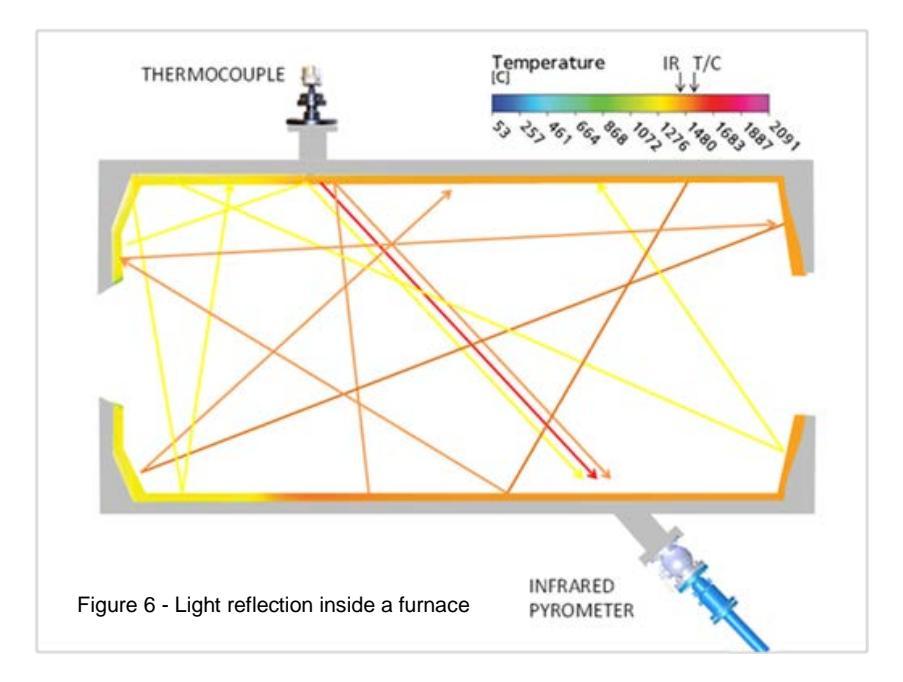
Inside a Claus furnace, where all the surfaces are radiating, there is an abundance of reflected energy, as shown in Figure 3. Thus reflections cannot be ignored.

These simulations demonstrate that in a furnace with large temperature gradients, a perfectly calibrated pyrometer may not read the same as a thermocouple, even if the pyrometer is pointed directly at the thermocouple's thermowell as shown in Figure 6. This is because the thermocouple measures only the temperature at its junction whereas the measurement of a pyrometer may be thought of as a weighted average of the temperatures in the furnace, with the weighting strongly dependent on the emissivity of the refractory material. References in the literature give a wide range of emissivities for high-alumina ceramics, ranging from 0.01 to 0.8. Determining the exact emissivities at the operating infrared wavelengths and at operating temperatures is a subject for further investigation beyond the scope of this paper.

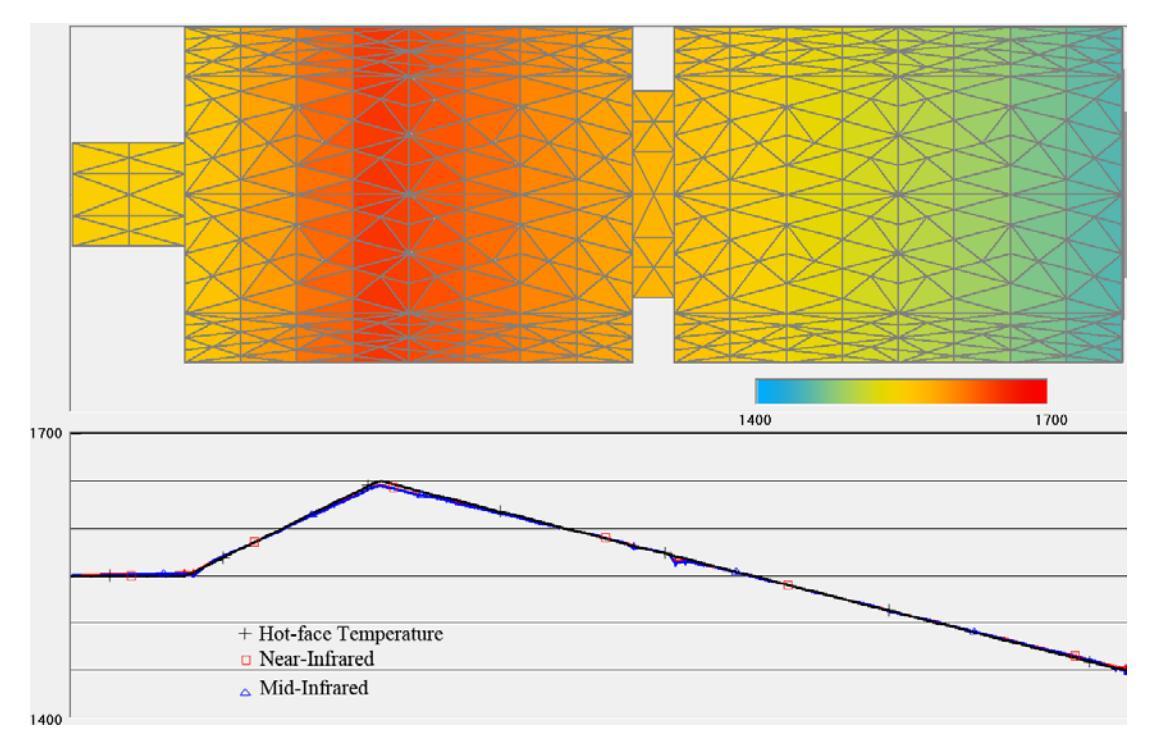
Figure 7 - Actual vs. Indicated Temperature with ε =0.9

Figure 7 shows a simulated run with the emissivity of the refractory set to 0.9. The result is what most people would expect from a pyrometer measuring refractory temperature. The pyrometer reading tracks almost exactly with the hot-face temperature.

The runs of Figure 7, Figure 8, and Figure 9 used a temperature profile that did not take into account the much cooler wall temperatures in the vicinity of the burner on the left and the waste heat boiler (WHB) tube sheet on the right. Figure 10 uses the same emissivities as Figure 9, but includes the effects of the cooler end conditions. Note that the indicated temperatures are reduced along the entire length of the furnace.

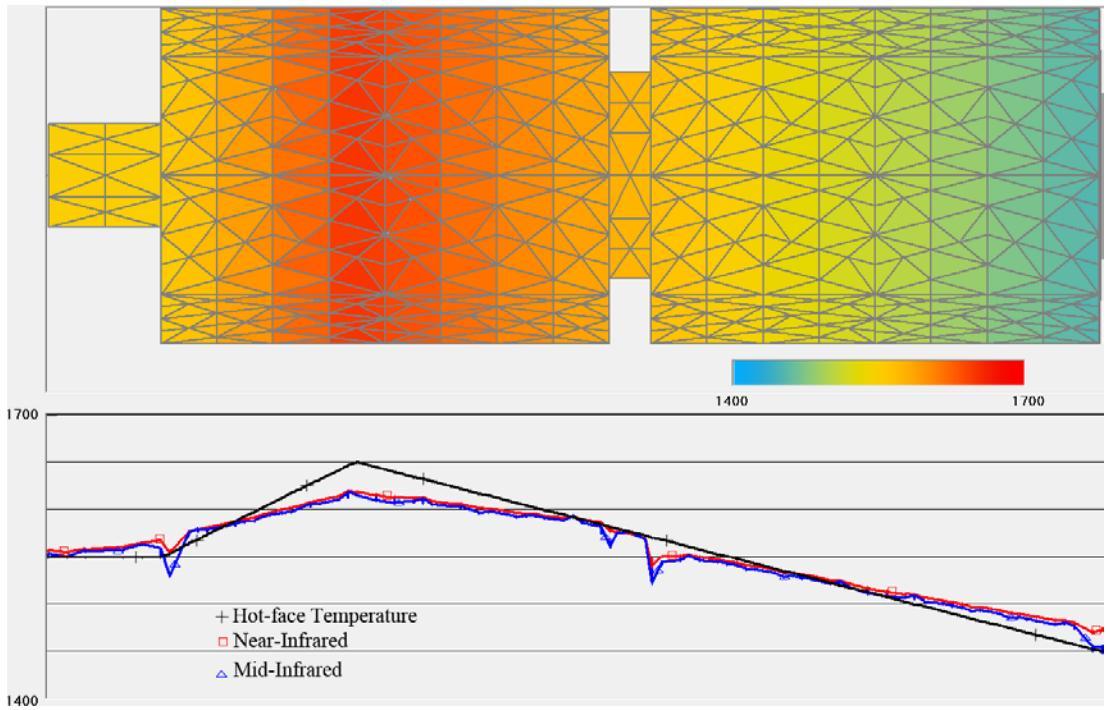
Figure 8 - Actual vs. Indicated Temperature with $\varepsilon = 0.4$

However, the emissivity of high alumina firebrick is likely not nearly as high as 0.9. The fact that firebrick is nearly white indicates that at visible wavelengths its reflectivity is fairly high and thus the emissivity is fairly low. Figure 8 shows a simulation run using an intermediate refractory emissivity of 0.4. The effects of reflections are quite evident as the warmer areas read a bit low and the cooler areas read a bit high.

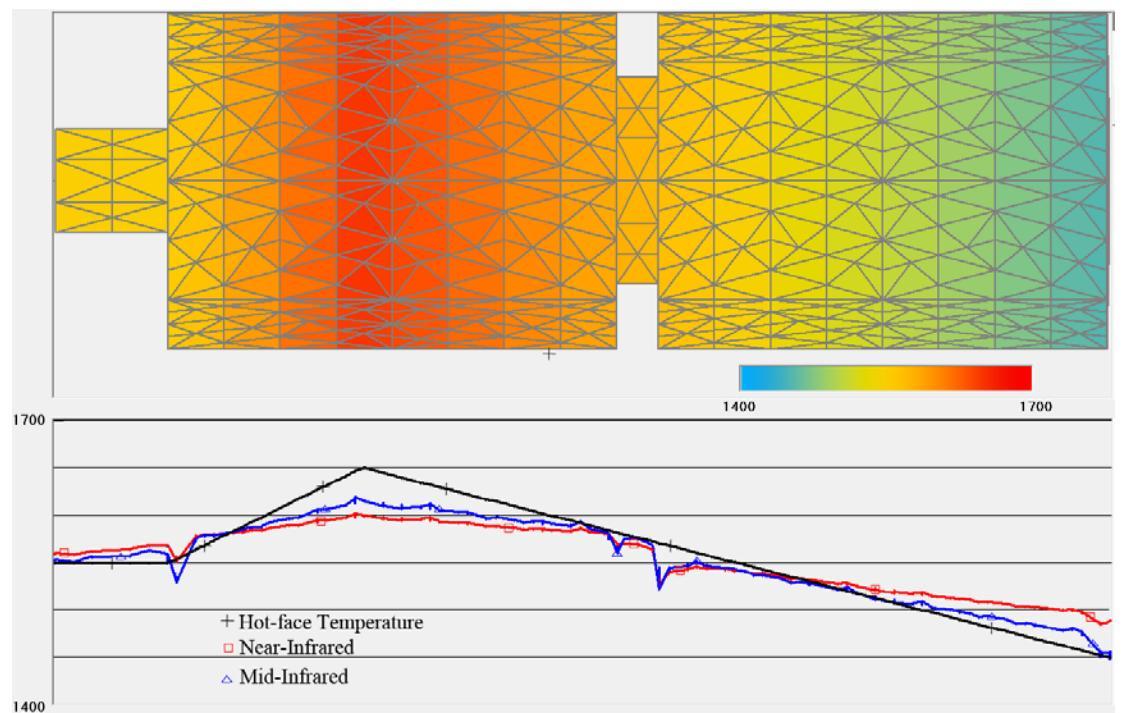
Figure 9 - Actual vs. Indicated Temperature with ε =0.2 (near-IR) ε =0.4(mid-IR)

The value of 0.4 may be representative of the emissivity at mid-infrared wavelengths, but at the near-infrared wavelength, an emissivity of around 0.2 may be more realistic. Figure 9 shows a simulation using $\varepsilon = 0.2$ at near-infrared wavelengths and $\varepsilon = 0.4$ at mid-infrared wavelengths. The near-infrared pyrometer shows more 'averaging' since the higher reflectivity at its wavelength causes light to be bounced around the furnace more.
